Ignorance, Uncertainty and Human Errors in Contemporary Construction

IGNORANCE, UNCERTAINTY AND HUMAN ERRORS IN BUILDING CONSTRUCTION

18 MAY 2017

PETER SARLOS
ARCHITECT : LAWYER : CHARTERED BUILDING SURVEYOR

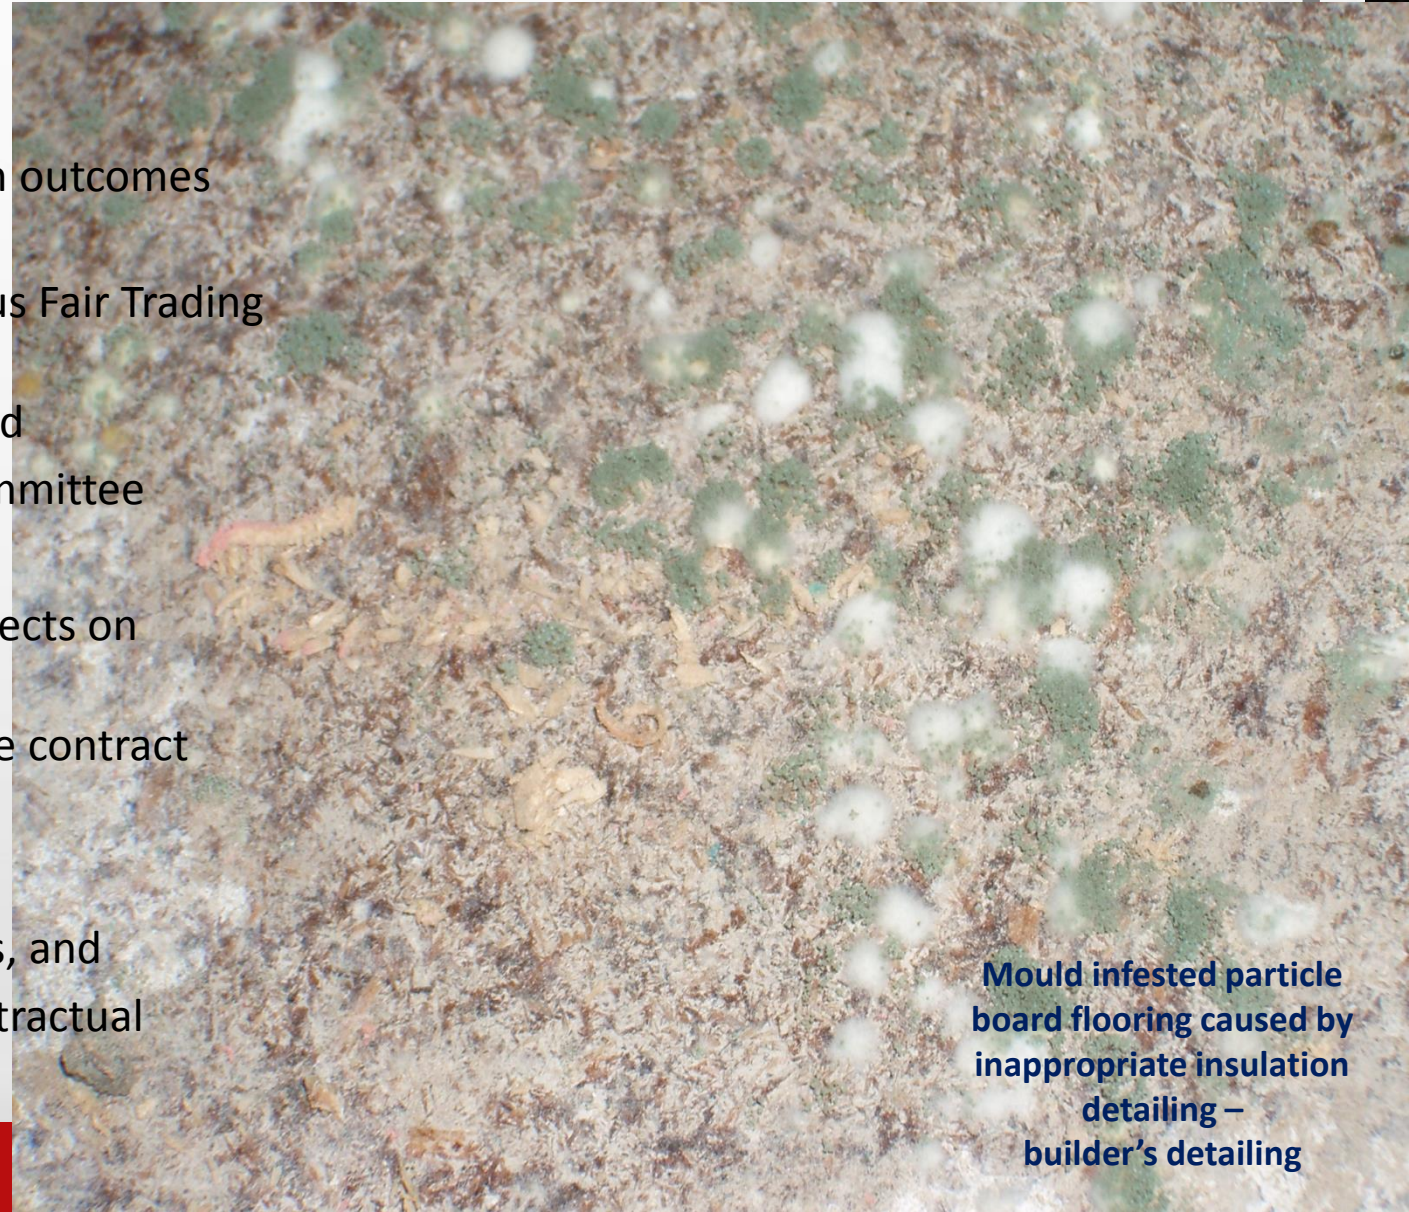
Mould infested particle board flooring caused by inappropriate insulation detailing – builder's detailing

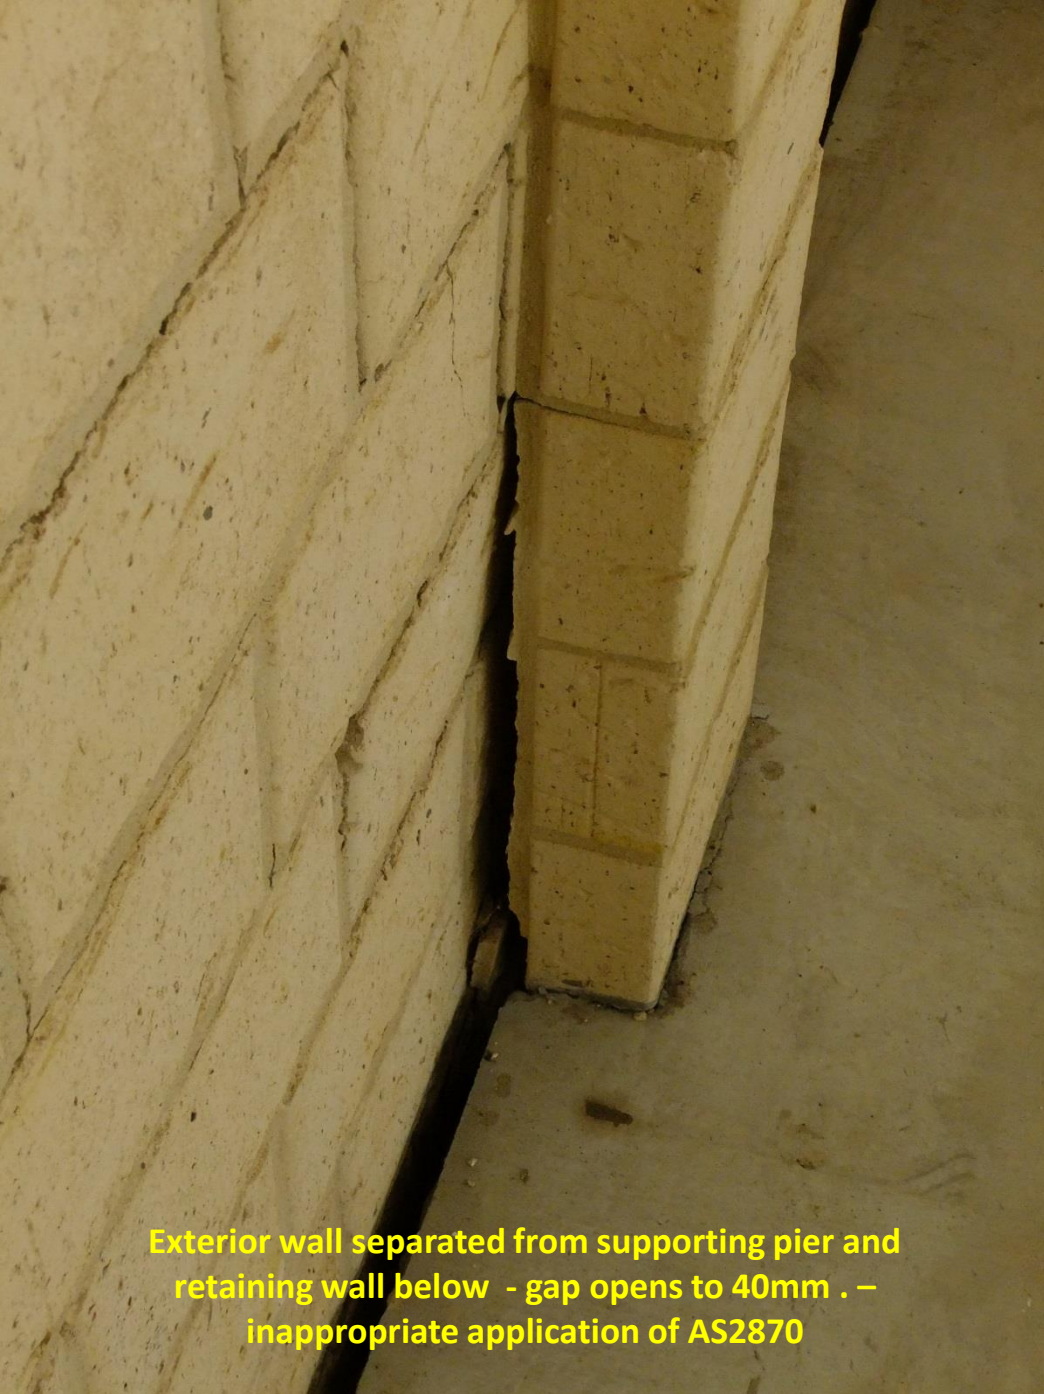
Exterior wall separated from supporting pier and retaining wall below - gap opens to 40mm . – inappropriate application of AS2870

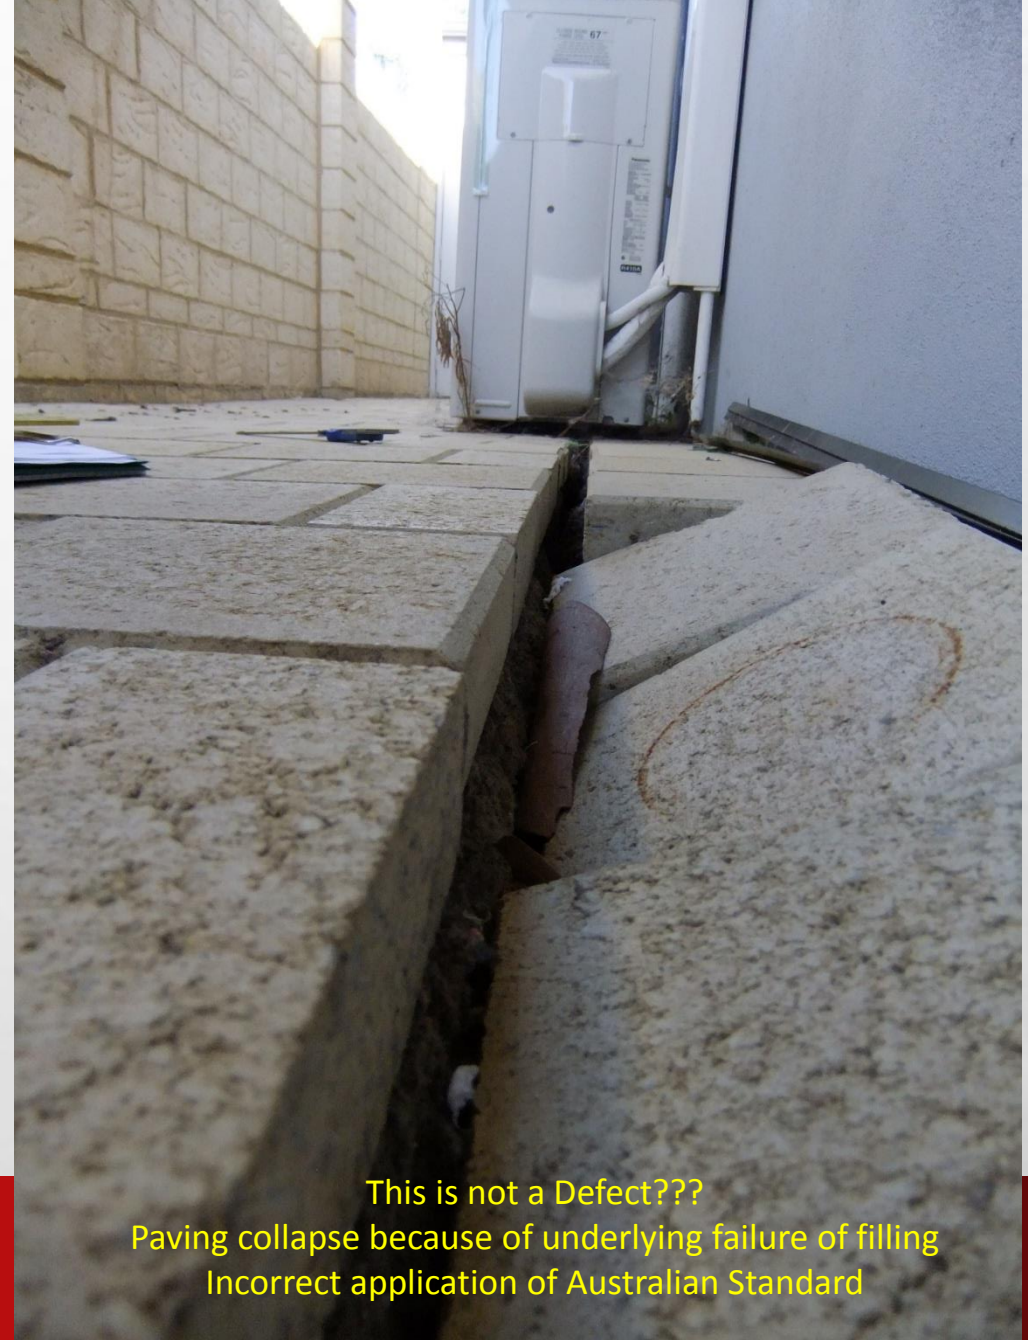
This is not a Defect???

Paving collapse because of underlying failure of filling
Incorrect application of Australian Standard

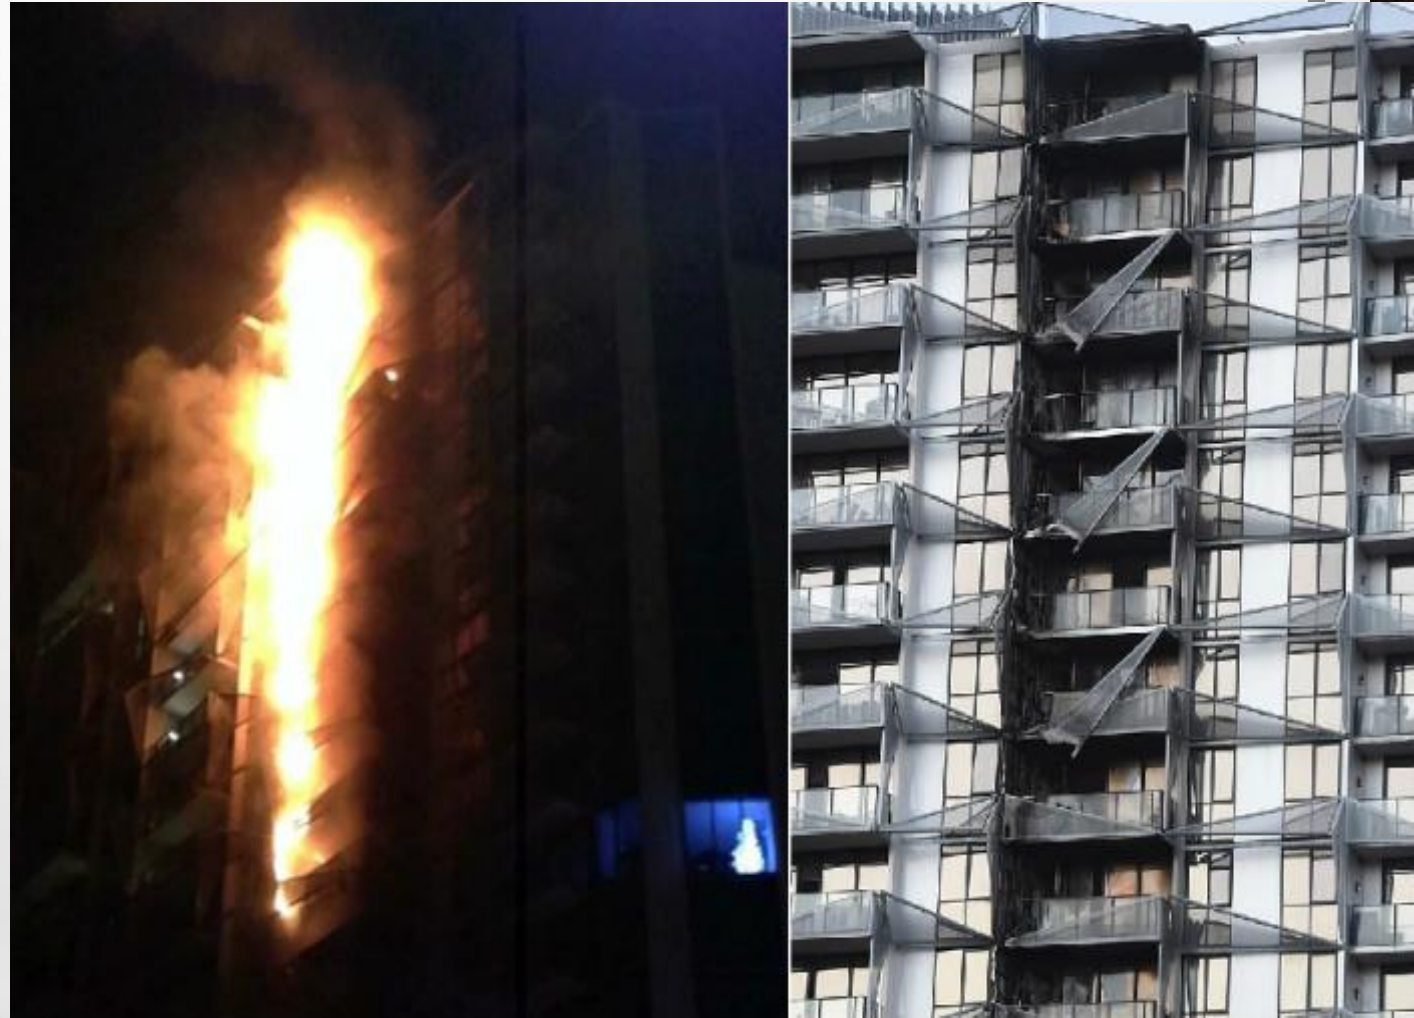
- **Lacrosse Fire, Docklands**

- \$15 million damage
 - Caused by cigarette in balcony
 - set fire to excessive storage of materials on balcony
 - Extending to wall cladding
 - Spread from 6th floor to 21st floor in less than 15 minutes
- Caused did not comply with NCC combustibility requirements

- Shared accommodation contributes to storage on balconies
- Contractor substitution
 - Incorrect certification of material
 - Material and certification by PM delegate

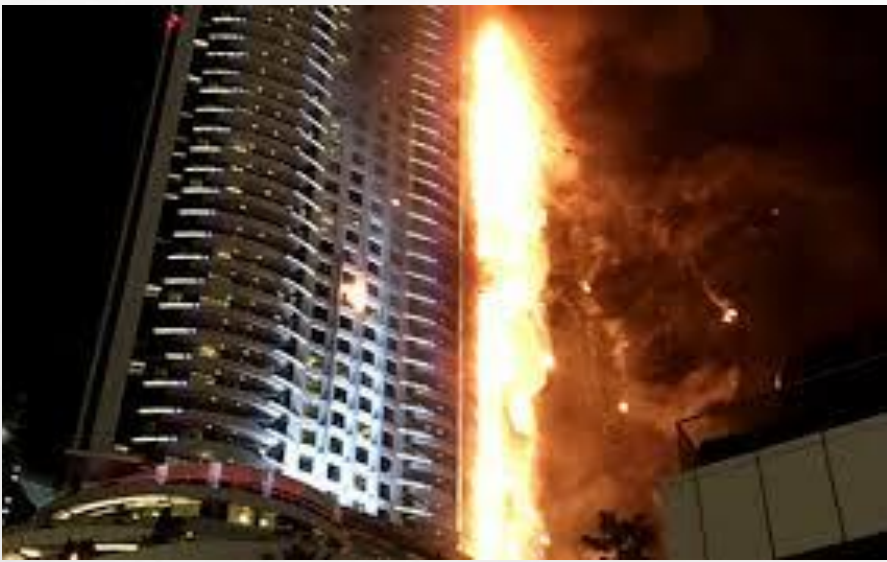
- Inferno in the 63-story The Address residential complex in Dubai where skyscraper blazes remain a worry.
- Fires have hit skyscrapers in Dubai and other cities in the UAE in recent years.
- A popular type of cladding covering the buildings that can be highly flammable.

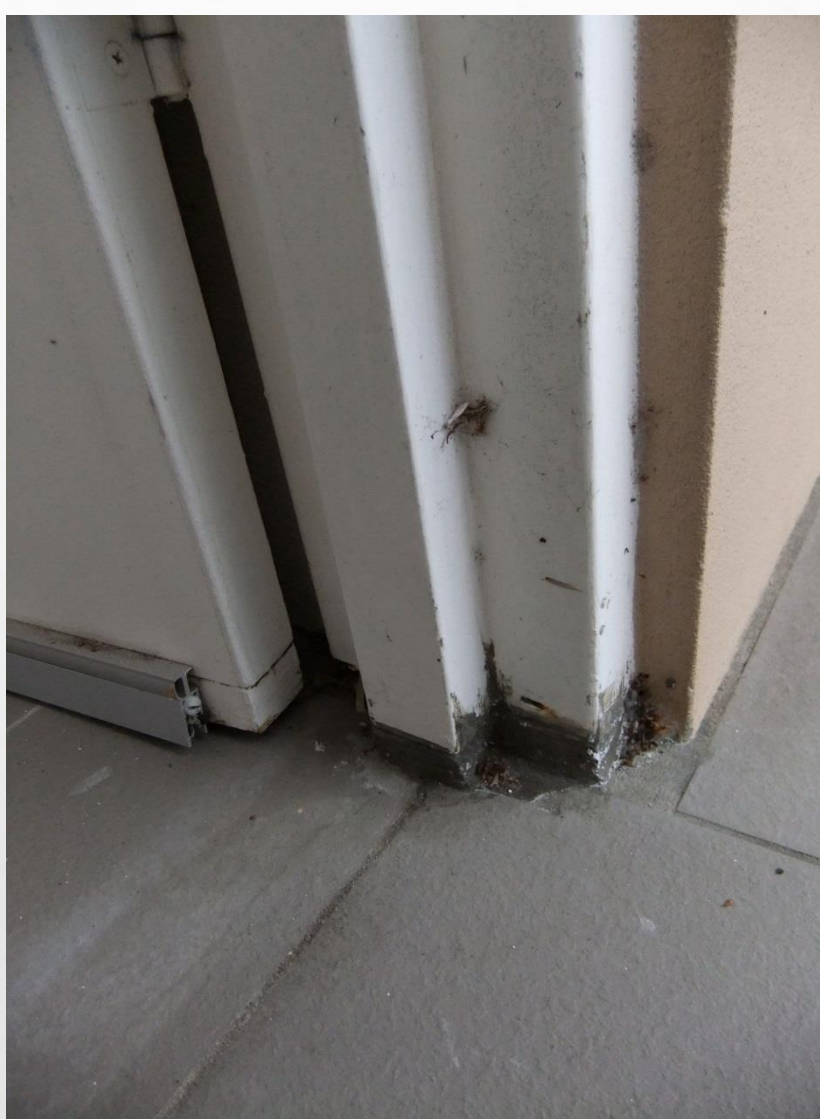
Fire door compromised - Step omitted - Door manufacturer designed for step not built – stormwater floods apartment

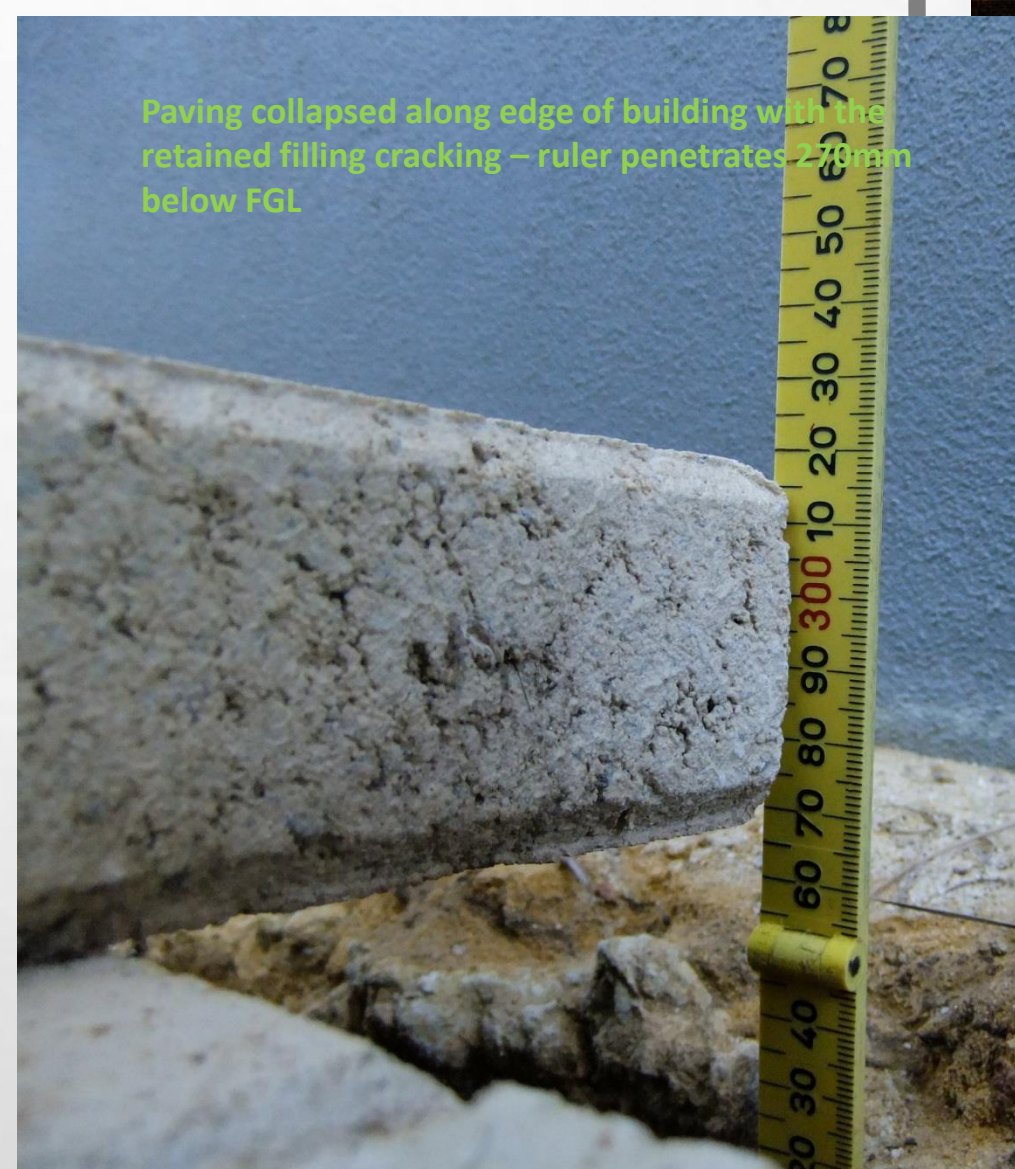
Collapse of fill caused by engineers error in interpreting public foundation data

Paving collapsed along edge of building with the retained filling cracking – ruler penetrates 278mm below FGL

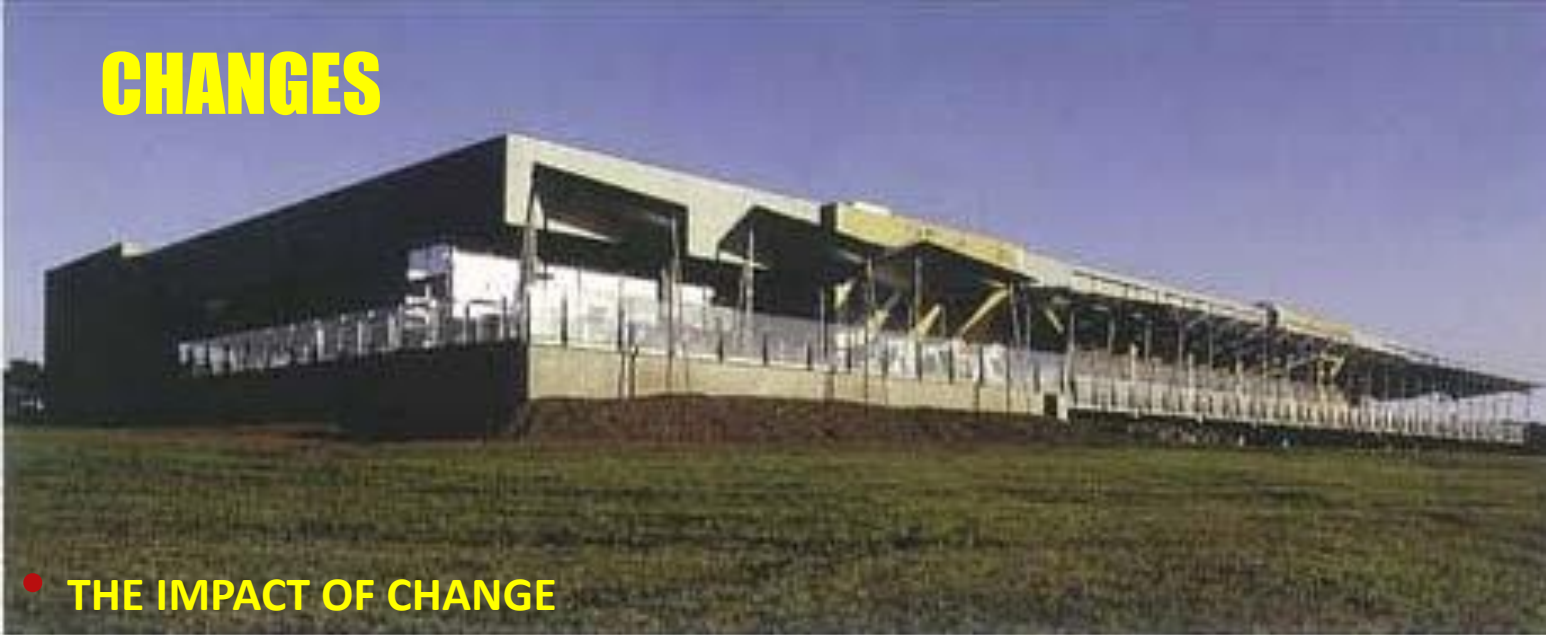
- Award winning design
- PM requires cost saving
- Remove SS handrail from balustrade
- Characterization of glass changes from infill to structural
- Change in characterisation not noticed by architect or engineer
- Glass fails causing accident resulting in injury
- Engineer claims problem outside of scope
- Architect claims outside of skill
